Reference: 21079

**RE: ABORIGINAL CULTURAL HERITAGE DUE DILIGENCE ADVICE FOR
HAPPY VALLEY LANDING, HAPPY VALLEY, NEW SOUTH WALES**

Austral Archaeology Pty Ltd (Austral) has been engaged by James Golsworthy Consulting to provide Aboriginal Cultural Heritage Due Diligence Advice (ACHDDA) for the proposed pump site at Happy Valley Landing, Happy Valley, New South Wales (NSW) [the study area]. This advice is intended to assist James Golsworthy Consulting in determining their obligations with regard to the *National Parks and Wildlife Act 1974* (NPW Act) and to determine whether the project will involve activities that may harm Aboriginal objects or places.

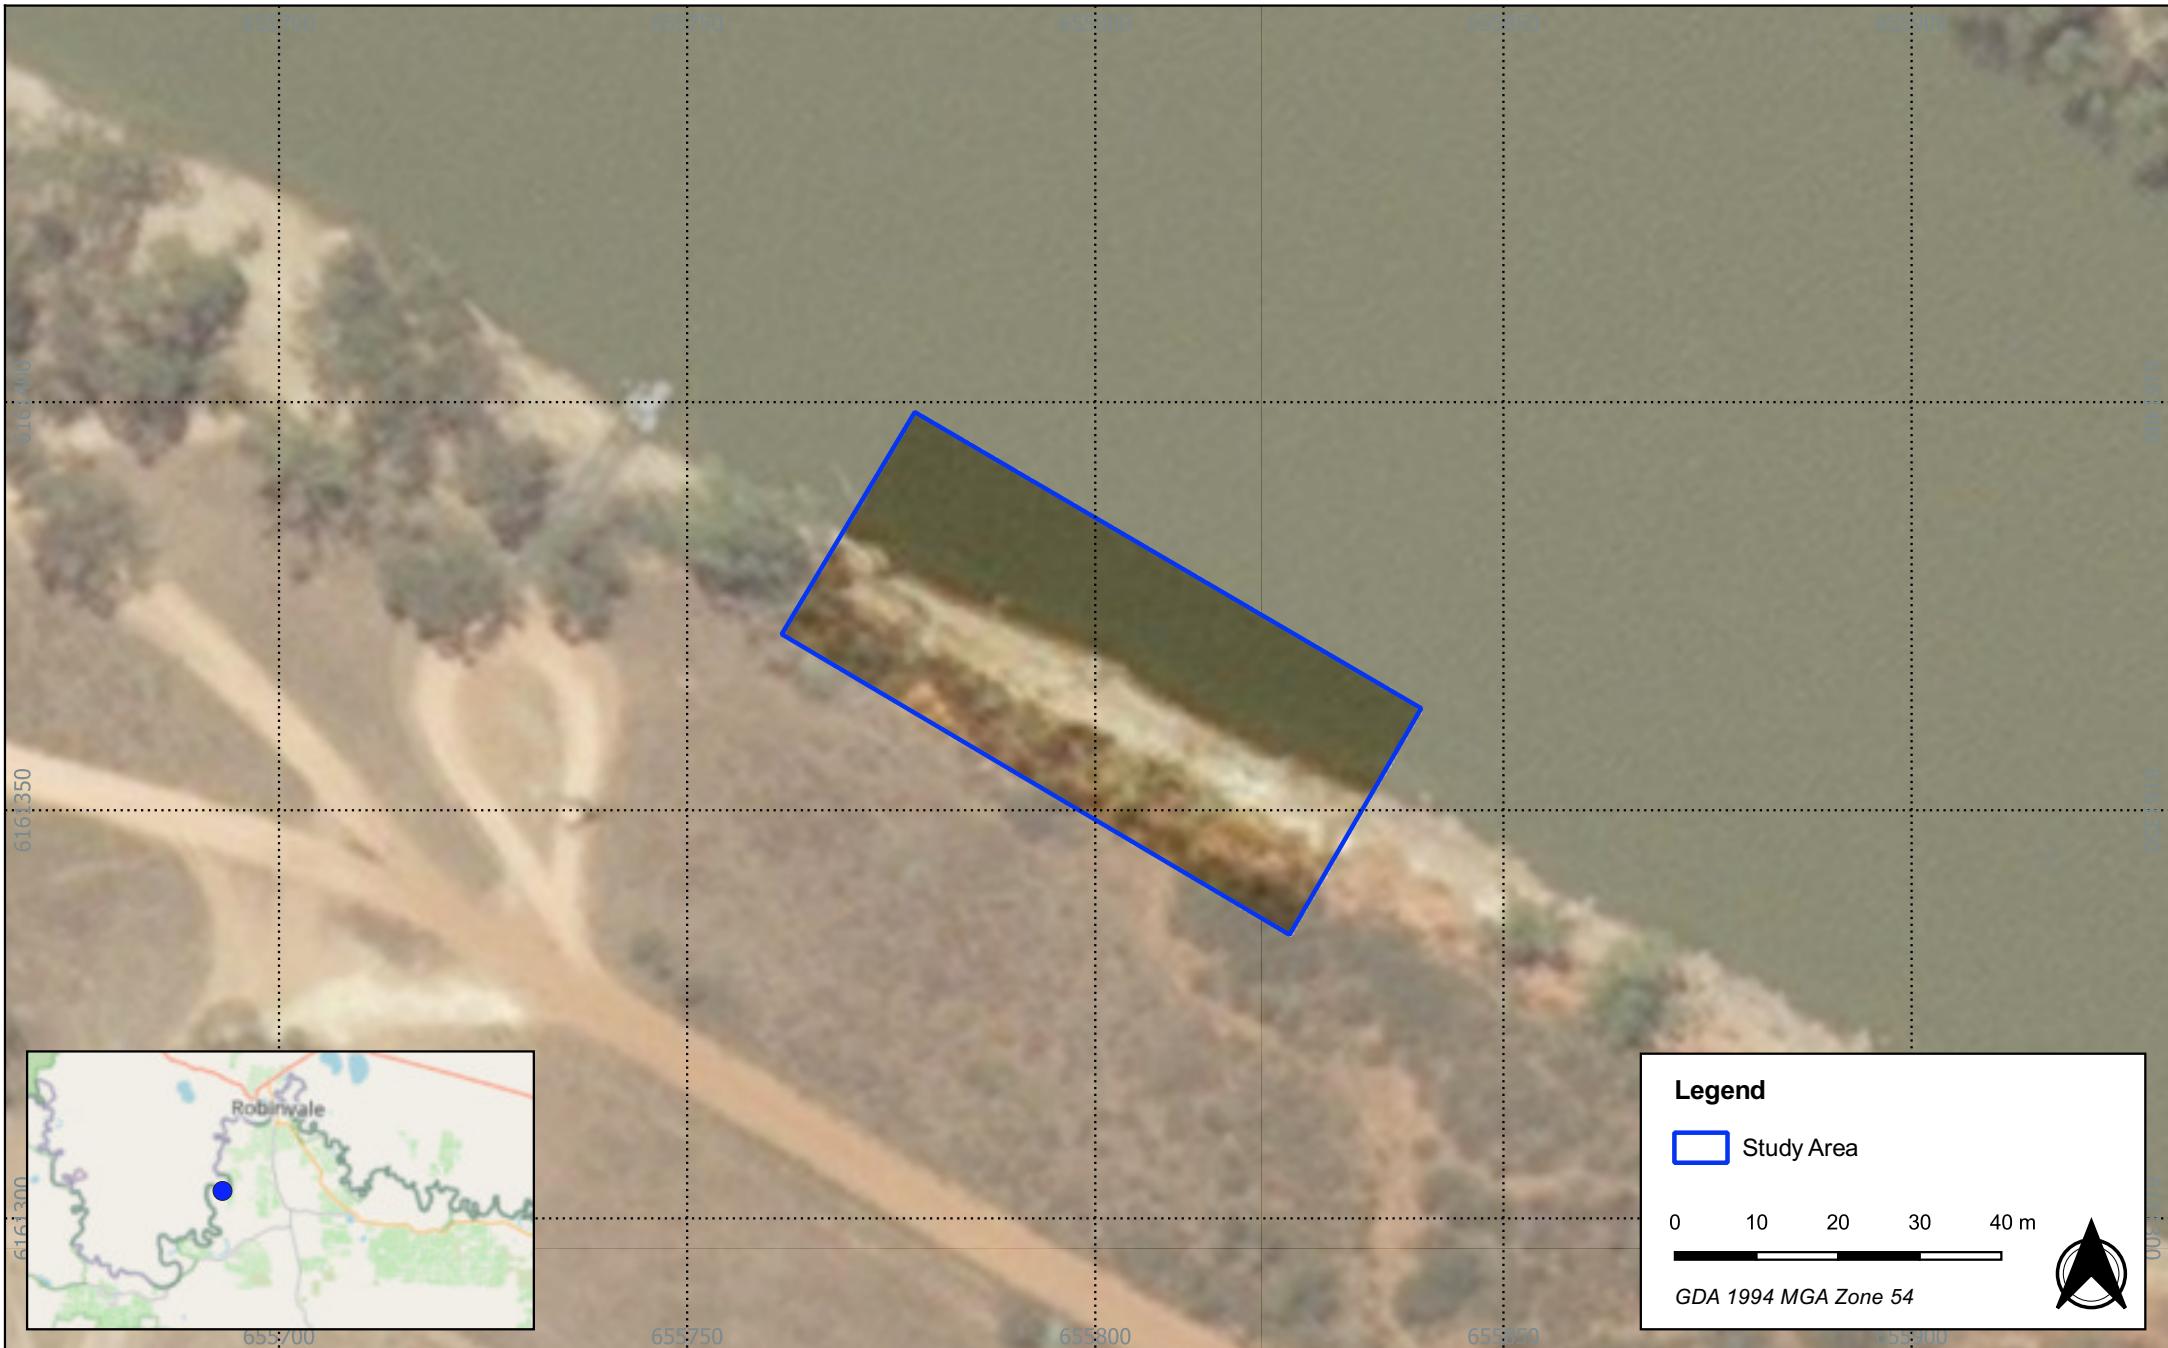
Figure 2 - Detailed aerial of the study area

The study area is approximately 0.208 hectares in area, and the proposed development is the installation of a pontoon and gantry pumping structure below the high water mark on the Victorian side of the Murray River, however, due to being below the high water mark of the river is spatially situated in New South Wales. As part of the proposed development, piles for anchoring will be installed in the study area, which will support the pontoon and the gantry pumping structure. As this ACHDDA will only focus on the developments below the high water mark, no advice is provided for the pipelines that will extend into Victoria.

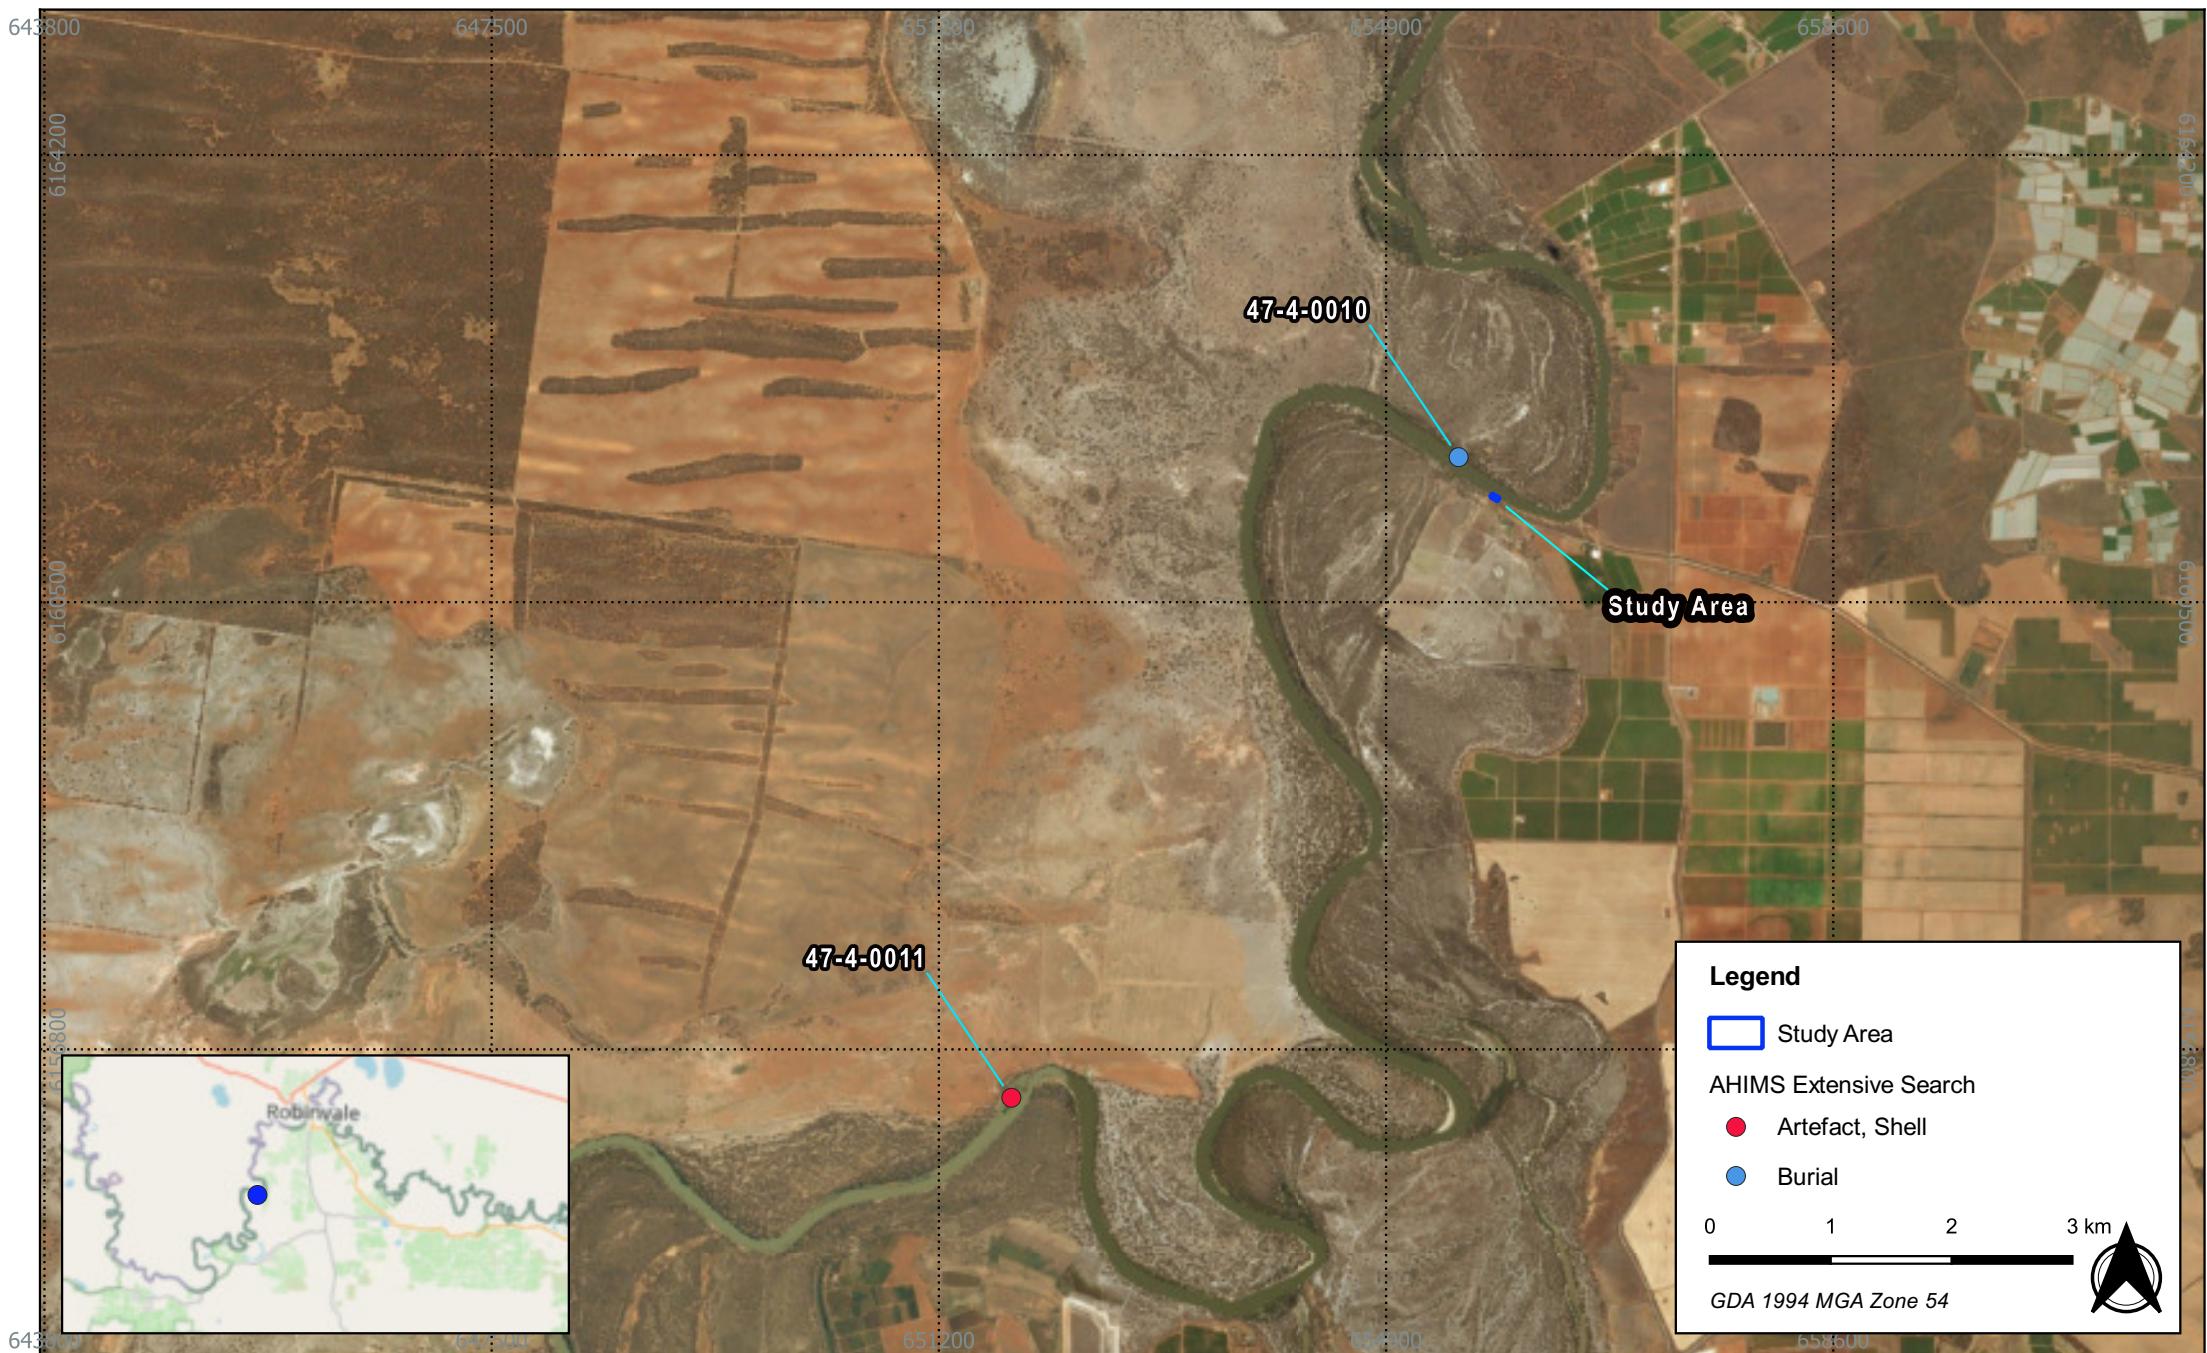
Figure 3 - AHIMS sites (Overview)

An extensive search of the Aboriginal Heritage Information Management System (AHIMS) database was conducted on 24 June 2021 (Client service ID: 601186). The search identified 2 Aboriginal archaeological sites within a 10 kilometre search area centred on the proposed study area. None of these registered sites are located within the study area (Figure 3). The mapping coordinates recorded for these sites were checked for consistency with their descriptions and location on maps from Aboriginal heritage reports where available. Spatial information for this report is displayed using the GDA94 Datum. Where AHIMS site records were provided on a different datum, they were converted using standard functions in QGIS software.

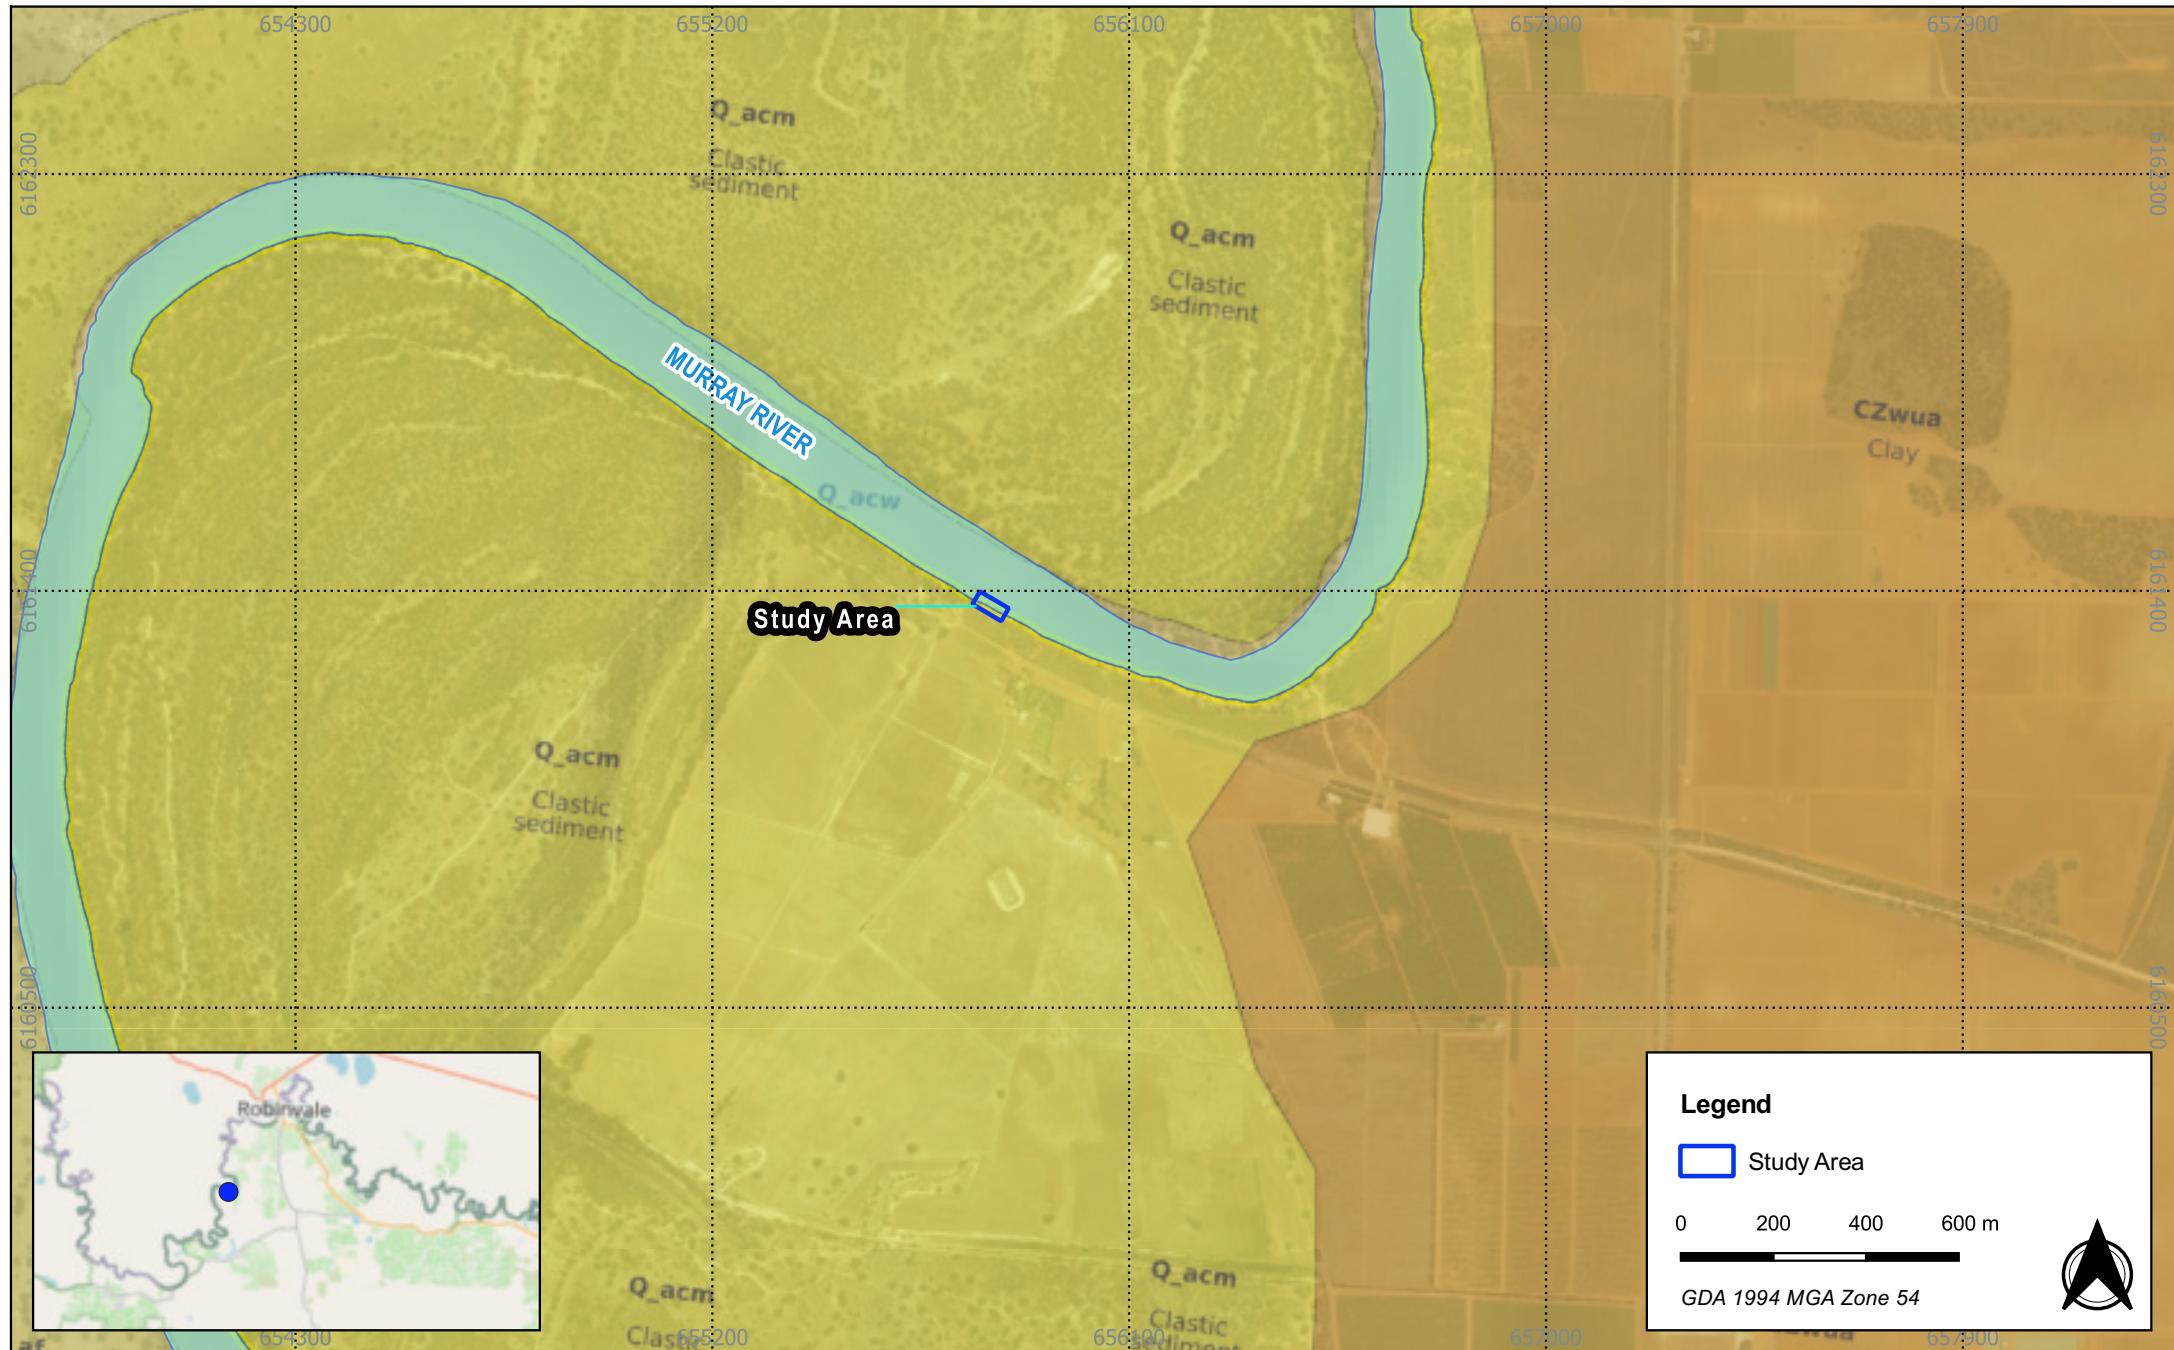
Figure 4 - Geology/Hydrology of the study area

Soils	The study area is characterised by Murray Channels and Floodplains (Figure 4). Generally, the river bank in the Euston area consists of a gray loam, overlaying a pale brown clayey sand with yellow mottles, which overlays a white and brown mottled clayey silt which overlays a clayey sand (Gill 1973, p.38). This suggests subsurface artefact concentrations (if any) will be shallow and unstratified.
Hydrology	<p>The major hydrological system associated with and adjacent to the study area is the Murray River, located in the south-eastern part of the Murray Basin (Figure 5). The Murray River has its major headwaters in the Australian Alps and runs approximately 3,750 kilometres to the Southern Ocean at Goolwa, South Australia. This permanent freshwater water source has many tributaries including other rivers, streams, paleo-channels, creeks, billabongs, swamps and levees that feed into the main river.</p> <p>Prior to European settlement and large scale infrastructure, the Murray River would have flooded seasonally each year (Coutts et al. 1979, p.29). During these periods of flooding, the areas of inundation would have supported a number of food resources for Aboriginal people, such as freshwater fish, shellfish species, other aquatic species and water birds (Pardoe 2014, p.114). Following the changes in the Holocene, the resources available changed with more stability in the environment leading to demographic and occupation changes (Pardoe 2014, p.114).</p>

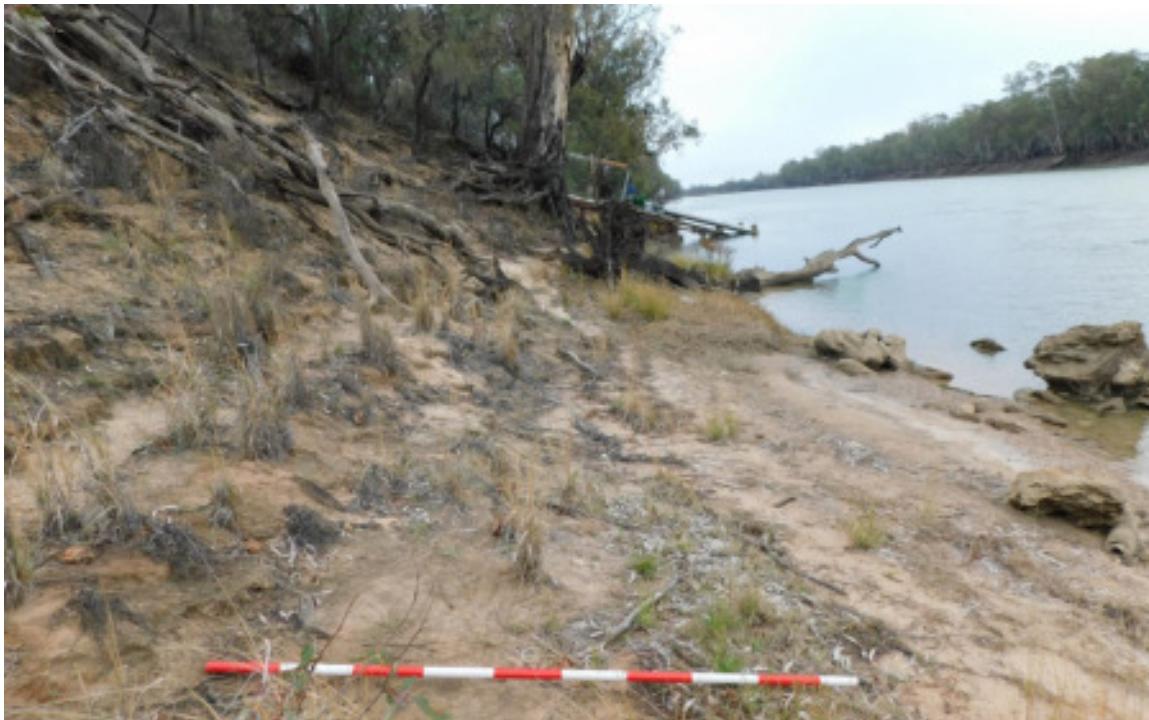
In general, the site inspection confirmed that the study area was below the high water mark and within a single landform of moderately sloped riverbank (Figure 7 and Figure 8). The disturbances in the study area are confined to small, naturally occurring erosional gullies on the higher river bank and stepped erosion from fluctuating river levels closer to the river. There was also evidence of burrowing animals, most likely rabbits. The river bank was characterised by high ground visibility (80%) and high exposure, recorded at 60%.

Figure 7 West facing view of the study area and pre-existing pump in the background.

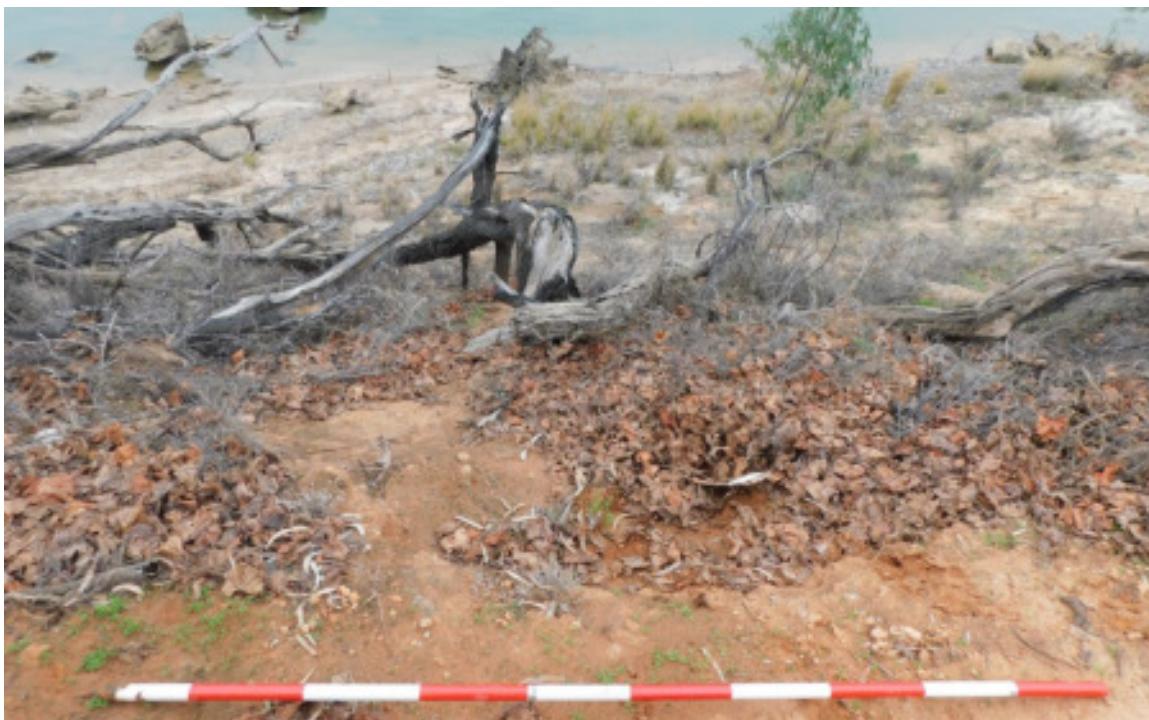
Figure 8 North facing view of the study area landscape.

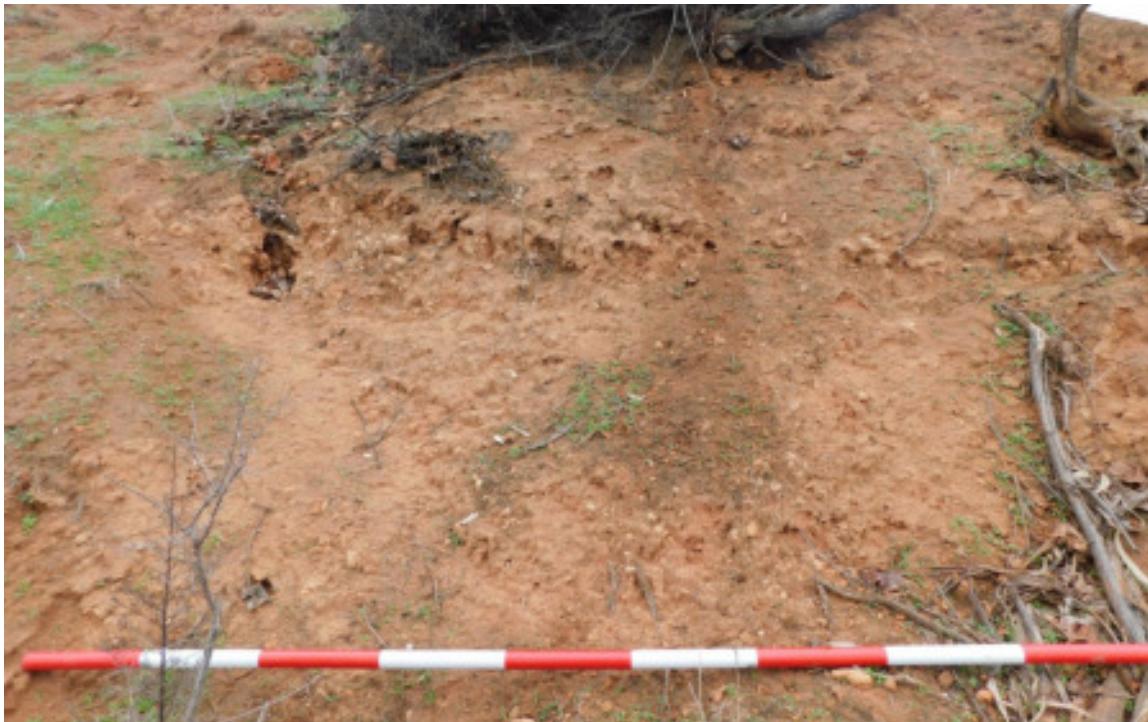
During the visual inspection, sporadic and dispersed freshwater mussel shell was identified on the higher portions of the riverbank, however, there was no burnt shell, charcoal or bone identified (Figure 9). This shell is not *in situ* and most likely originates from the higher alluvial terraces above the high water mark. No Aboriginal sites were identified within the study area.

Figure 9 **South facing view of the sporadic shell.**

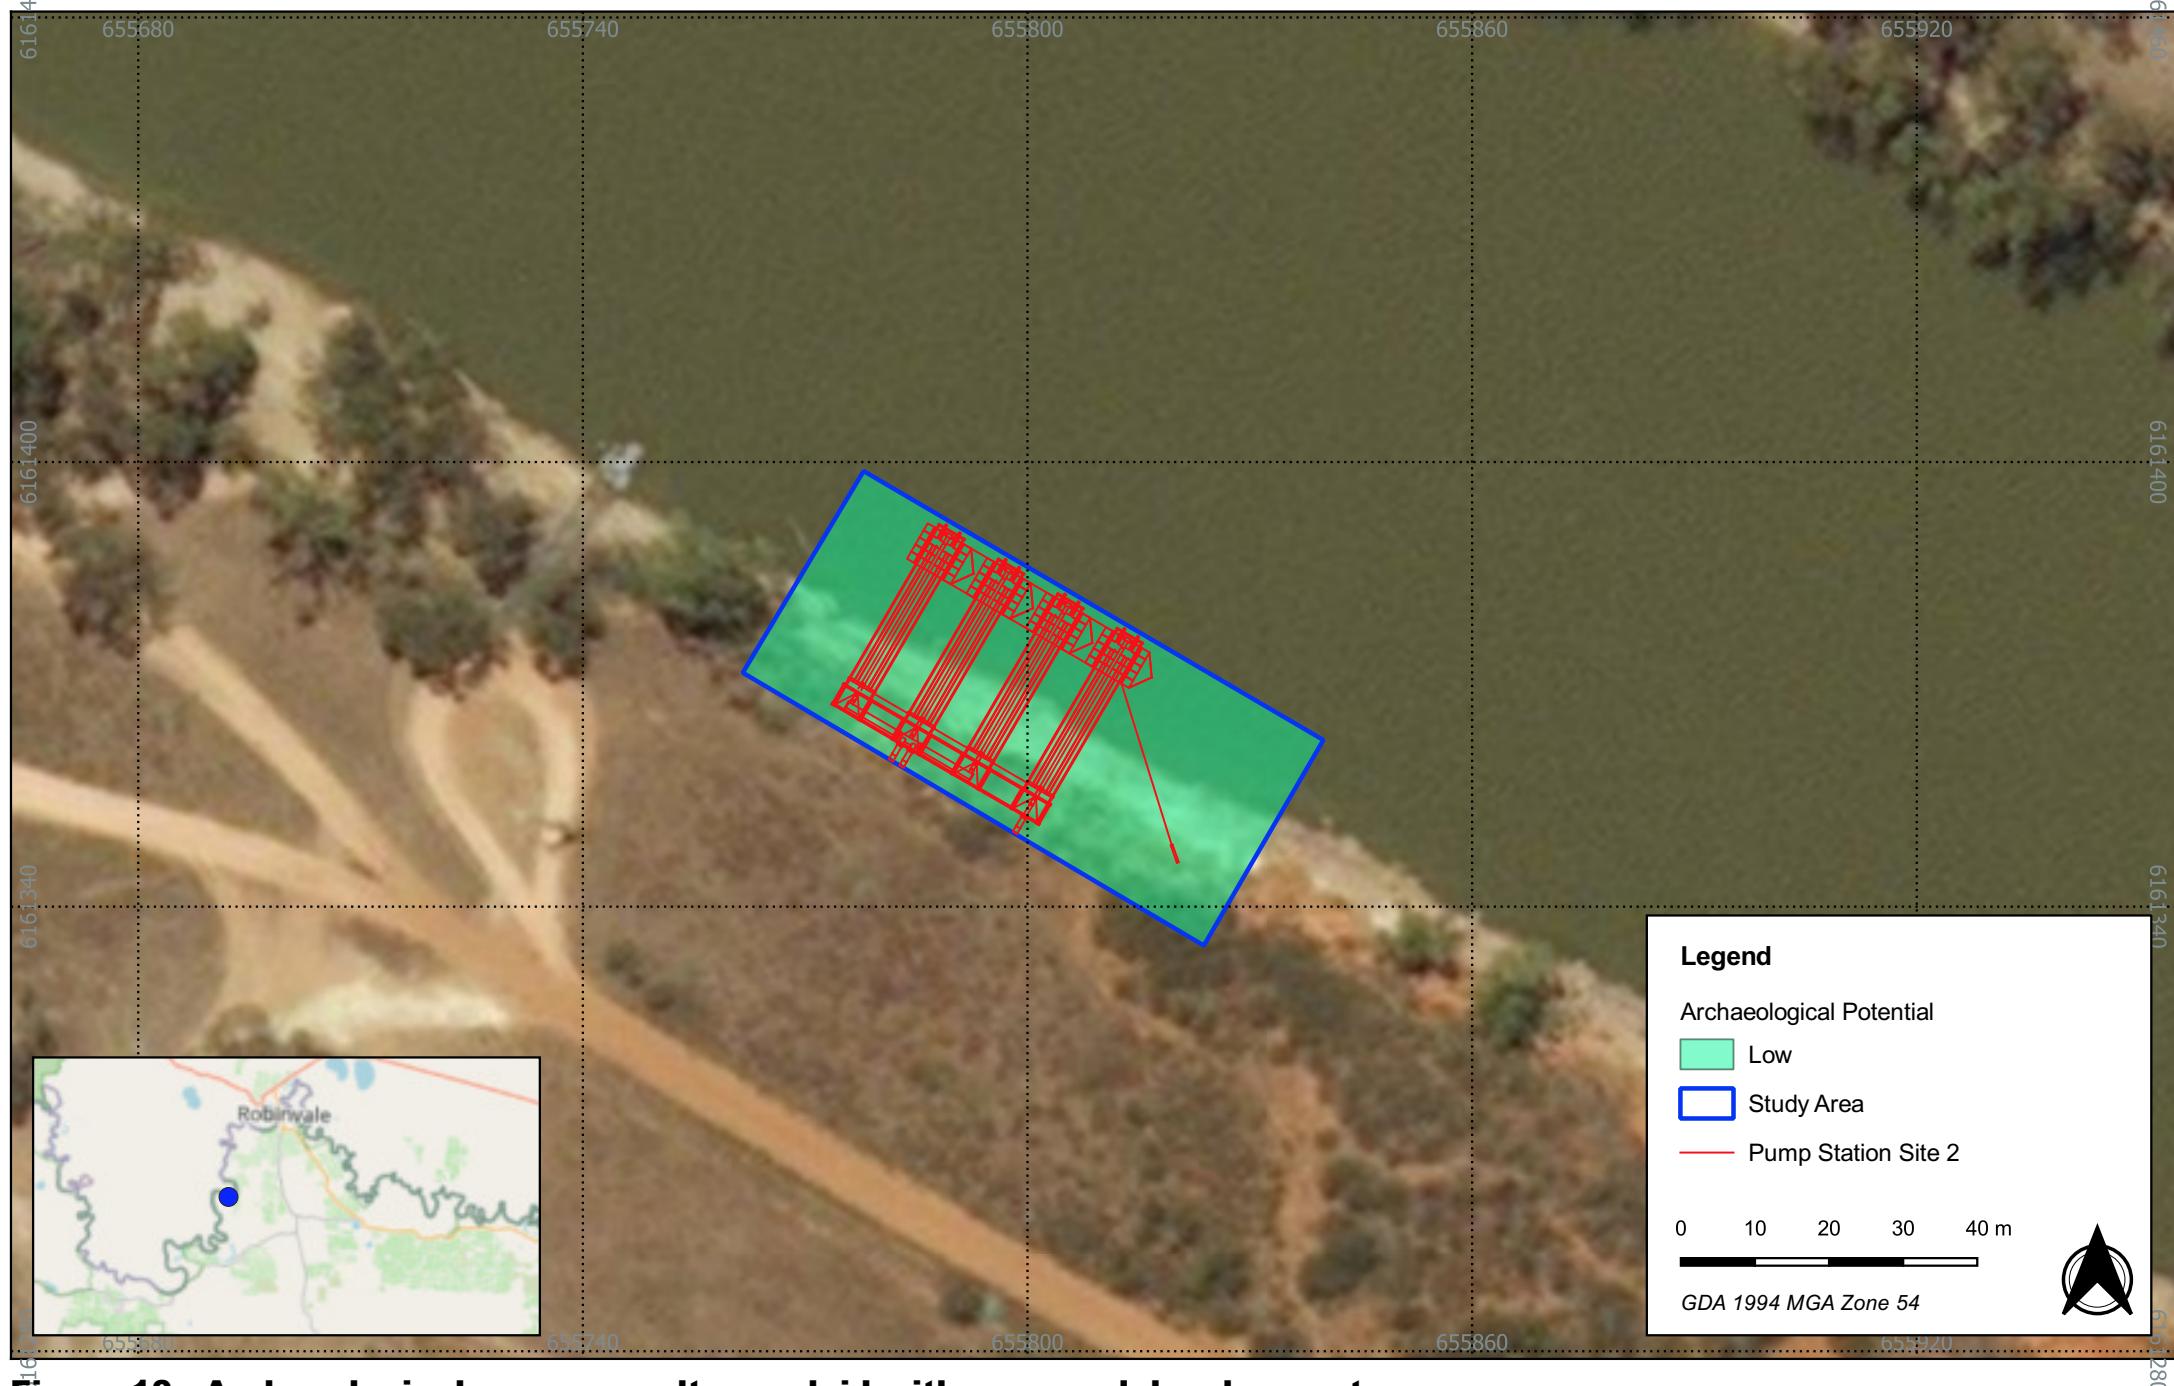
Despite Aboriginal sites associated with the Murray River, the survey noted that the study area is located in a landform is likely to be prone to flooding and as such is unlikely to be suitable for Aboriginal occupation. The results of the visual inspection are outlined in Figure 10.

Figure 10 - Archaeological survey results overlaid with proposed development

Based upon the outcome of Steps 1 to 4 of the code, further assessment is not warranted based. As such the project may proceed with caution. The following recommendations apply:
